Pore-pressure generation and fluidization in a loess landslide triggered by the 1920 Haiyuan earthquake, China: A case study

Wang, Gonghui; Zhang, Dexuan; Furuya, Gen; Yang, Jun

Wang, Gonghui ...[et al]. Pore-pressure generation and fluidization in a loess landslide triggered by the 1920 Haiyuan earthquake, China: A case study. Engineering Geology 2014, 174: 36-45

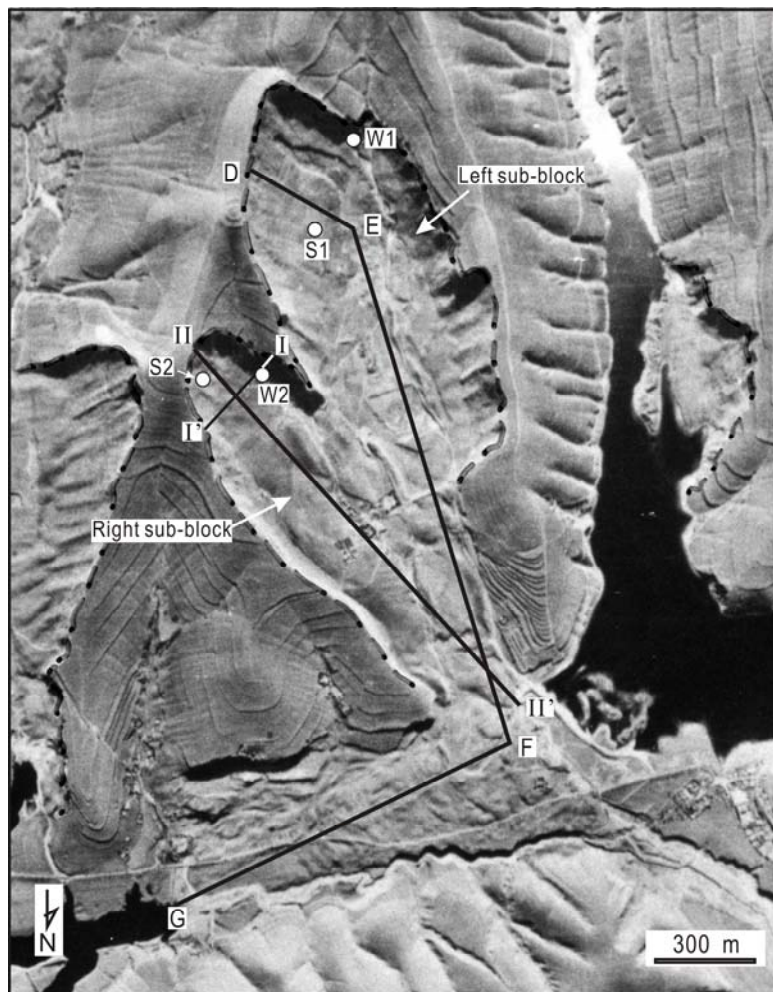
Fig. 2. Dangjiacha landslide in Xiji, Ningxia, triggered by the 1920 Haiyuan Earthquake (photo was taken in 1966). W1, W2: locations of Well 1 and Well 2; S1, S2: sampling locations of undisturbed and disturbed loess, respectively.

Located approximately 25 km southwest of Xiji city, Dangjiacha landslide was the most catastrophic one triggered by the 1920 Haiyuan earthquake. Figs. 2 and 3 present an airphoto (taken in 1966) and the topography of the landslide area, respectively. The landslide was composed of two big blocks (left and right, referring to viewing the landslide area in the downhill direction), both originating from the same side of a mountain ridge. We surveyed the landslide during 1994, 2002, 2003 and 2005. We used a total-station surveying instrument to create a transverse cross section along I-I' and longitudinal sections along lines II-II' and D-E-F-G (Figs. 2, 4). The left block of the landslide originated from a slope of about 20 degrees and nearly all of it evacuated the source area, while the right block stopped after moving a relatively shorter distance. The left block has a maximum width of about 520 m and length of 2000 m, while the right block has a maximum width of 400 m and length of 1500 m. The locations of the sliding surfaces of these two blocks were inferred from field observations and present topography, and by assuming that the ridges that form the block boundaries (Fig. 2) had not been greatly disturbed. As shown in Fig. 4, the maximum thicknesses were inferred to be approximately 50 m and 40 m for the left and right blocks, respectively. The total volume of the landslide was estimated to be approximately $2.1 \times 10^7 \text{ m}^3$, assuming an average deposit thickness of 20 m. Our observations suggest that the right block moved about 230 m (assuming that the materials at point P in Fig. 4b originated from the uppermost part of the scar) and did not experience much deformation during movement. In contrast, the left block was nearly entirely displaced out of the source area, moved northwards for a distance of about 2000 m before turning westwards for an additional 1100 m, and its deposit dammed the valley. A barrier lake formed that is about 5 km long and 380 m wide; it is the largest of the recorded impounded lakes formed by this earthquake (Derbyshire et al., 2000).

We observed standing water (Fig. 5) and shallow groundwater (Points W1 and W2 in Fig. 2) in the landslide source areas, even 80 years after the 1920 earthquake. Point W2 references a well that supplies water for several families, with a water table 22 m (measured on March 26, 2003) below the present ground surface. We were told that the groundwater table in W2 was usually higher during summer. Well W1 is very shallow. To examine the aquifer location, we dug a pit near W1 on March 20, 2005, and found groundwater at a depth of about 2 m (Fig. 5c).

From Fig. 2, it is apparent that the landslide materials that underwent long-runout movement mainly came from the left block where a valley existed, while the main body of the displaced material on the right block remained in the source area after moving about 230 m. Although the groundwater condition at the time of landsliding is not available, it is reasonable to infer that the soil layers near or above the sliding surface of the left block may have been fully or highly saturated, while those of the right block may have been partially saturated. Zhang and Wang (2007) examined the effect of the saturation degree on the steady-state strength of loess and found that the apparent friction angles of unsaturated loess were 31° and 26.6° at saturation degrees of 5.4% and 32.6%, respectively. These values are much greater than the saturated friction angle we obtained from our test results (about 2.9°, Fig.11). Therefore, it is reasonable to infer that liquefaction of the fully or highly saturated loess layer was the main reason for the high mobility. Due to the introduction of seismic load during the earthquake, high pore-water pressure was generated within the loess near the sliding surface, resulting in initiation of the landslide. Further increase of pore-water pressure with increasing shear displacement after shear failure occurred may have elevated the mobility of displaced landslide materials.

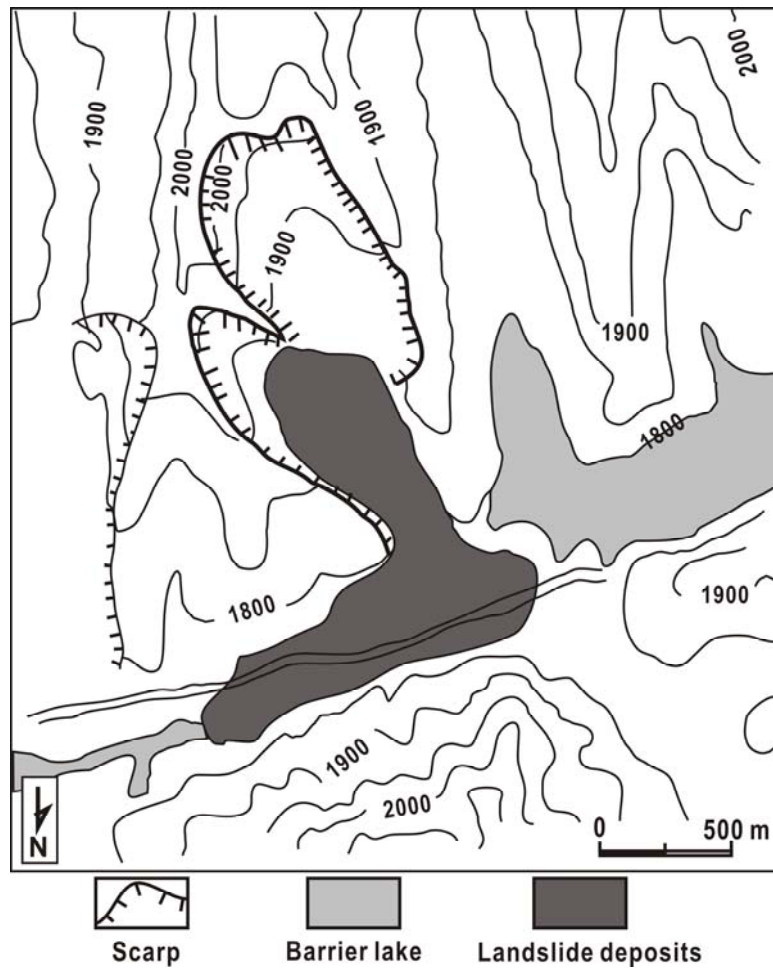
Fig. 3. Topographic map of the Dangjiacha landslide area.

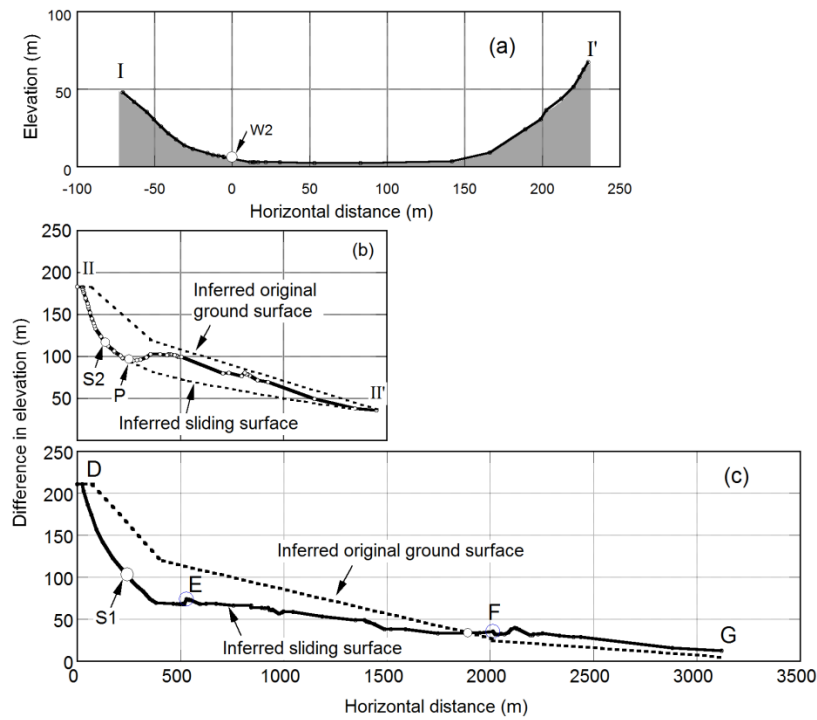
Fig. 4. Cross section along Line I-I' (a), longitude section along Line II-II' (b) and Line D-E-F-G (c) in Fig. 2,

respectively.

samples (two blocks, each sized 50 cm × 40 cm × 40 cm) at location S1 and disturbed samples (about 80 kg) at location S2 from the main scarps (see Figs. 2 and 4). These samples were taken from two pits that were dug approximately 1 m deep. We hypothesized that liquefaction failure of the water-saturated loess was the main reason for this long-runout landslide, and if the soil at location S1 was liquefiable, then all soil layers would be liquefiable as they had higher void ratios than at S1.

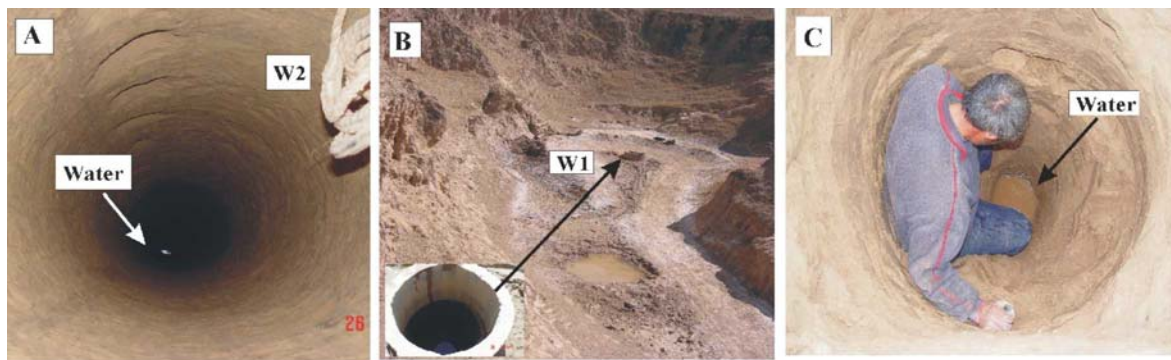
Fig. 5. Wells located in the right (a) and left (b) sliding blocks and the investigation pit (c) near the well W1

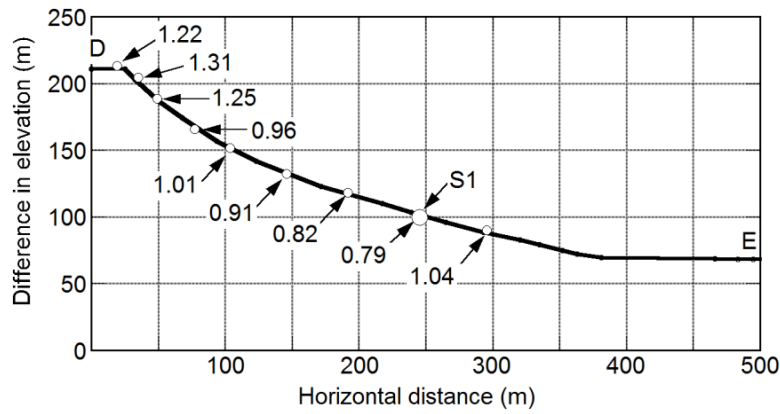
Fig. 6. Void ratios of loess soils at different elevations along Line D-E in Fig.2. S1: Sampling location of undisturbed loess.

We measured the in-situ densities of the loess soils at multiple heights on the main scarp (along line D-E in Fig. 2), and then calculated the void ratios of these soil layers after measuring the specific gravity of the loess (see Fig. 6). The soil layers at different elevations had different void ratios, ranging from 0.79 to 1.31. Generally, soils at lower elevation had lower void ratio, and the minimum void ratio (highest density) was measured for location S1. To study the initiation and movement mechanisms of the landslide in the laboratory, we took intact

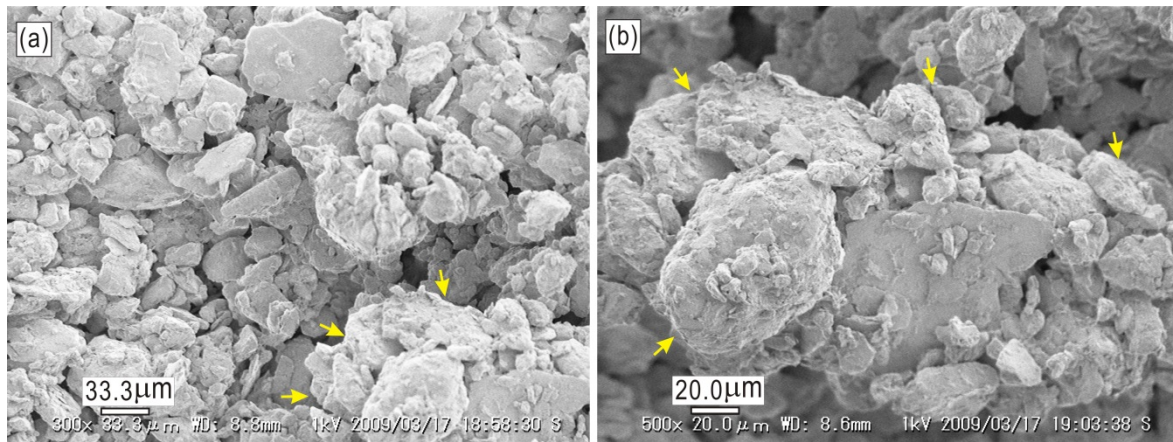
Fig. 8. Microstructures of undisturbed sample. (a)×300, and (b) ×500.

The microstructures of the undisturbed and remolded loess samples were observed using the SEM technique (Fig. 8 and Fig. 9). Both samples consist of a loosely packed silt skeleton with finer particles coating larger particles forming aggregates. However, the aggregates in the undisturbed loess form bigger clusters (like pupa), while those in the remolded loess form a relatively homogenous structure.

when at the same density. This change in the slope of the FLL may result from the variation in the microstructure of the samples. As seen in Figs. 8 and 9, the aggregates in the undisturbed sample are larger, probably due to the presence of cementing bonds that may be destroyed during the remolding process.

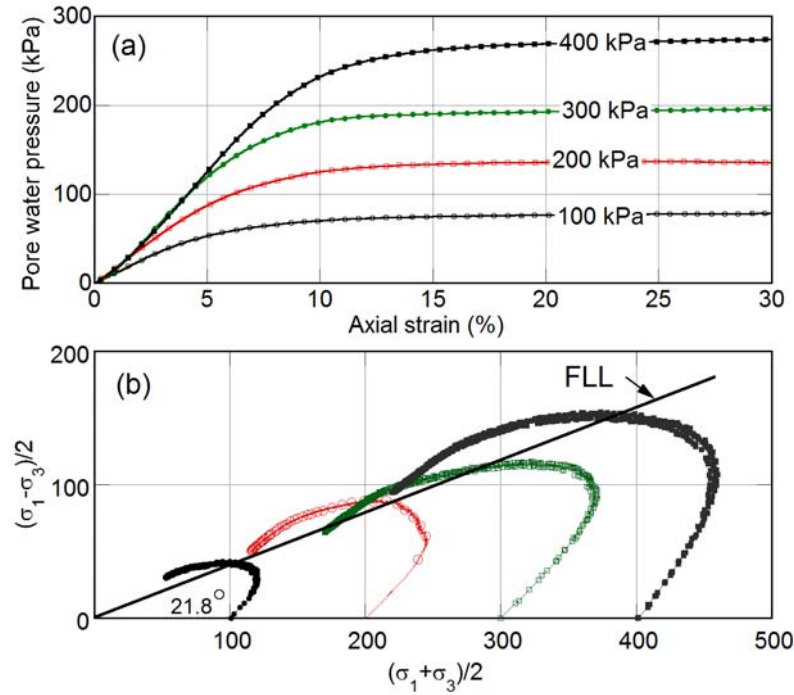
Fig. 10. Undrained triaxial compression test results on saturated undisturbed loess samples ($e=0.79$). (a)

Pore-water pressure against axial strain; (b) Effective stress path. FLL: Flow Liquefaction Line.

A series of consolidated-undrained triaxial compression tests was performed on undisturbed samples. The specimens had a height of 10 cm and a diameter of 5 cm. All specimens were saturated with de-aired water assisted by CO₂ saturation. Water saturation was ensured by obtaining a B value (Skempton, 1954) of at least 0.95. After saturation, the specimens were consolidated under a given cell pressure, and then compressed under undrained conditions following the strain-controlled method. Axial strain was increased at a rate of 0.01% per minute. The specimens were consolidated and tested at cell pressures of 100, 200, 300, and 400 kPa. Note that these cell pressures were used for observing the collapse behavior at different initial consolidation stresses, as done in many studies (Sladen et al., 1985; Ishihara, 1993). The triaxial compression at each cell pressure was terminated when the axial strain reached 30%. Fig. 10 presents the test results in the form of pore-water pressure against axial strain (Fig. 10a) and effective stress path (Fig. 10b). It can be seen that high pore pressure was generated, resulting in a remarkable decrease in effective stress. The final pore pressures in the tests were as great as 65% of the initial cell pressures. The locus of peak points in the effective stress paths can be well fitted by a straight line passing through the origin. This line is widely known as the flow liquefaction line (FLL) (Vaid

and Chern, 1983, 1985; Lade, 1993; Ishihara, 1993; Kramer, 1996; Yang, 2002), which indicates the initiation of flow deformation. The stress ratio, defined as the ratio of q ($=(\sigma_1 - \sigma_3)/2$) to p' ($=(\sigma_1 + \sigma_3)/2$), is approximately 0.4, which corresponds to a mobilized friction angle of about 21.8 degrees. From these test results (Fig. 10b), we can conclude that the loess is susceptible to flow liquefaction failure.

If the stress path crosses the FLL during undrained shear, flow liquefaction will be initiated regardless of whether the loading is cyclic or monotonic (Void and Chern, 1983). Because the test results presented in Fig. 10 were obtained from the densest undisturbed loess sample, it is reasonable to infer that once the stress condition in the loess layer reaches the FLL due to the introduction of seismic loading, flow liquefaction will be triggered and the shear resistance will rapidly drop to the steady-state strength.

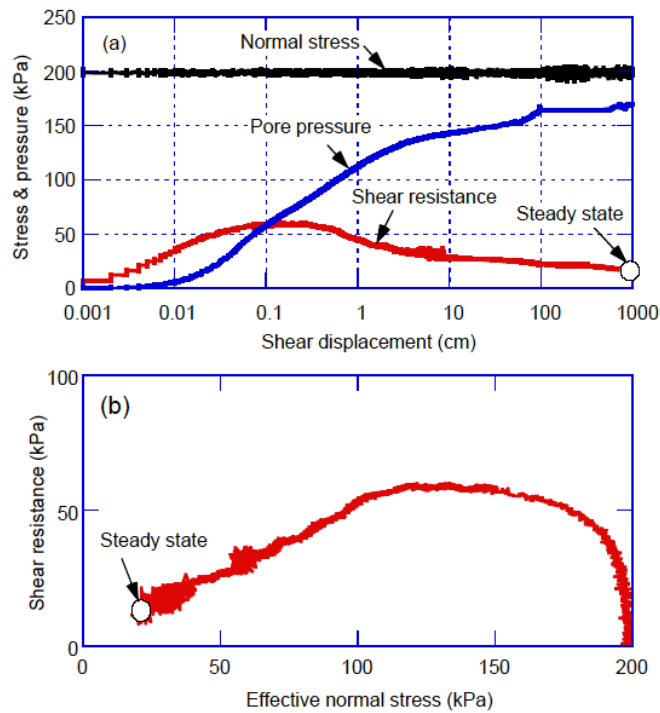
Fig. 11. Undrained response of water-saturated loess sample to monotonic shearing. (a) Normal stress, shear

resistance and pore-water pressure versus shear displacement; (b) Effective stress path ($e = 1.06$)

The results of a test on a water-saturated loess sample with initial void ratio of 1.06 are shown in Fig. 11, where normal stress, pore-water pressure, and shear resistance are plotted against shear displacement (Fig. 11a). Fig. 11b shows the effective-stress path. It is noted that pore pressures are measured by pore pressure transducers connected to a gutter (4×4 mm) located along the entire circumference of the inner wall of the outer ring in the upper cylinder pair of the specimen chamber, 2 mm above the shear surface. More details on the pore-water pressure monitoring system can be found in Sassa et al. (2003). From Fig. 11a, it can be seen that the pore-water pressure increased with increasing shear displacement before reaching a great value (about 85% of the applied normal stress), while shear resistance decreased to a small, nearly constant value (about 10 kPa) after about 1000 cm of shear displacement; hence, steady-state resistance was reached.

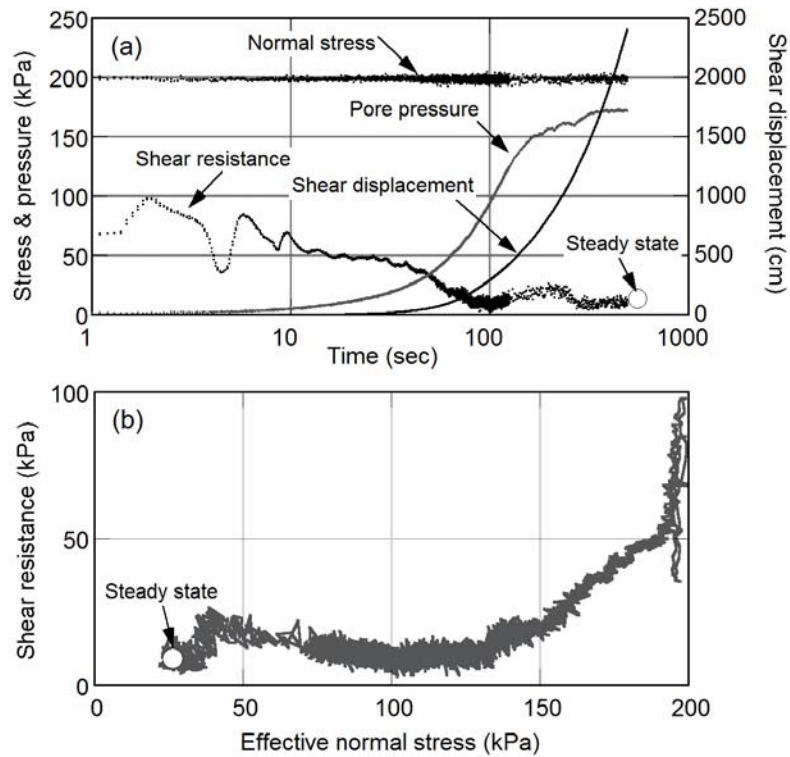
Fig. 12. Undrained response of water-saturated loess sample to cyclic loading in ring shear test. (a) Time series data of normal stress, shear resistance, pore-water pressure and shear displacement; (b) Effective stress path ($e = 0.99$)

Cyclic loading tests were also conducted on a water-saturated loess sample. After saturation, the sample was consolidated under a normal stress of 200 kPa while a shear stress of 80 kPa was applied. After consolidation, a cyclic shear loading was applied under undrained conditions with an amplitude of 60 kPa and frequency of 0.25 Hz, while the normal stress was kept constant. Fig. 12 presents the test results in the form of time-series data of normal stress, shear resistance and pore-water pressure (Fig. 12a), and in the form of the effective stress path (Fig. 12b). Shear failure was triggered during the first cycle and pore-water pressure increased continuously thereafter, while shear resistance decreased until reaching a small, constant value (about 7.6 kPa). It is noted that the measured shear resistance before the occurrence of shear failure represented the applied shear loading, but after failure shear loading greater than the shear resistance of soil could not be applied (Wang et al., 2007). Hence, the intended amplitude of the cyclic loading is not apparent in Fig. 11, although the frequency of the applied cyclic loading is. From Figs. 11 and 12, it can be concluded that the water-saturated loess samples are highly liquefiable under undrained monotonic or cyclic shearing.

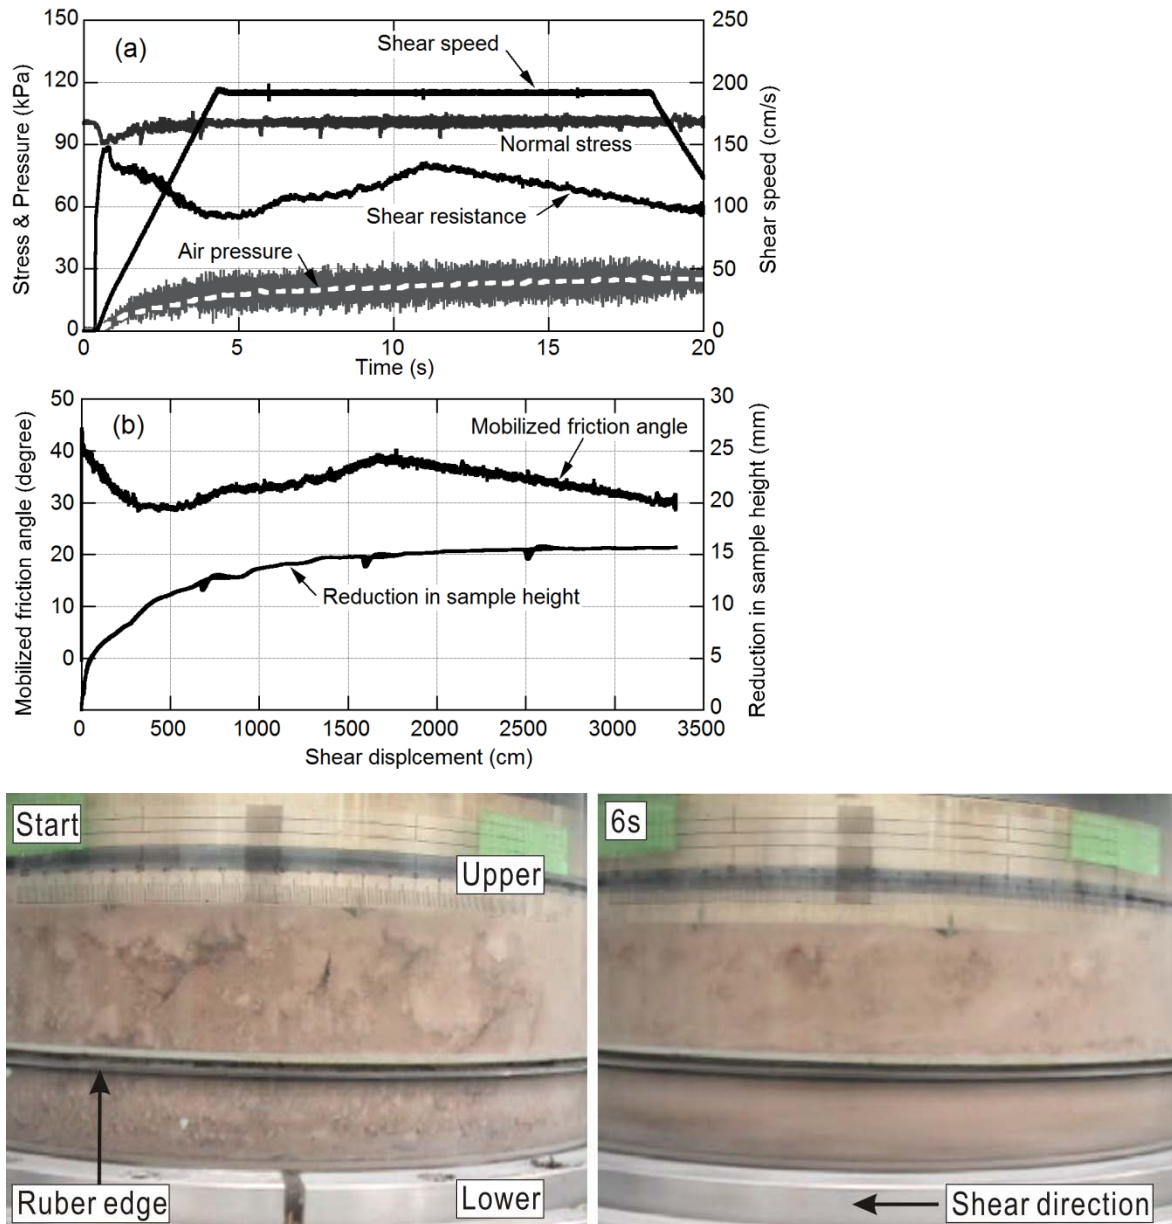
Fig. 13. Undrained response to fast shearing of loess sample in natural water content state with entrapped air.

(a) Time series data; (b) Mobilized friction angle and reduction in sample height versus shear displacement; (c) Specimen states before shearing (left) and after 6 seconds of shearing (right) ($e = 1.42$).

Because the landslide area is located in an arid region and the loess has high porosity, one may argue that the low permeability of the loess prevents air from readily escaping so liquefaction can be triggered in dry loess (Ter-Stepanian, 1998). However, this hypothesis has never been examined by laboratory tests. Here, to evaluate the possible effect of entrapped air on the high mobility of displaced loess, a series of fast shear tests was conducted on a loess sample at its natural water content (measured as 8.5%). The loess (some of which was in undisturbed blocks) was first placed into the shear box without tamping such that the specimen was in a very loose state with high porosity. After the sample was normally consolidated under a normal stress of 100 kPa, the shear box was switched to the undrained condition and the sample was sheared by increasing the shear speed quickly (up to 2 m/s within 4 seconds). The results are shown in Fig. 13. It can be seen that air pressure increased relatively quickly during the initial 4 seconds, and then tended to reach a constant value with further shearing (Fig. 13a). During shearing, the specimen showed significant height reduction due to collapse of the soil structure and the compression of pore air. Fig. 13c presents photos transferred from video records. Before shearing, the specimen was rich in void space with a void ratio of 1.42. During shearing, shear was localized in the shear zone and some big void spaces in the soil above the shear zone (upper layer) still remained even after the shear resistance reached steady state at a shear velocity of 2 m/s. The generated air pressure was about 25% of the normal stress, which could not lead to a significant loss of shear resistance. The mobilized minimum shear

strength (τ_r) was about 55 kPa, which gave a mobilized friction angle ($\arctan(\tau_r/\sigma_n)$) of 28 degrees. However, the slope angle is about 20 degrees in the source area and is less than 2 degrees in the runout area (e.g., from Point D to E in Fig. 4). Therefore, this mobilized friction angle would not lead to the long runout movement.

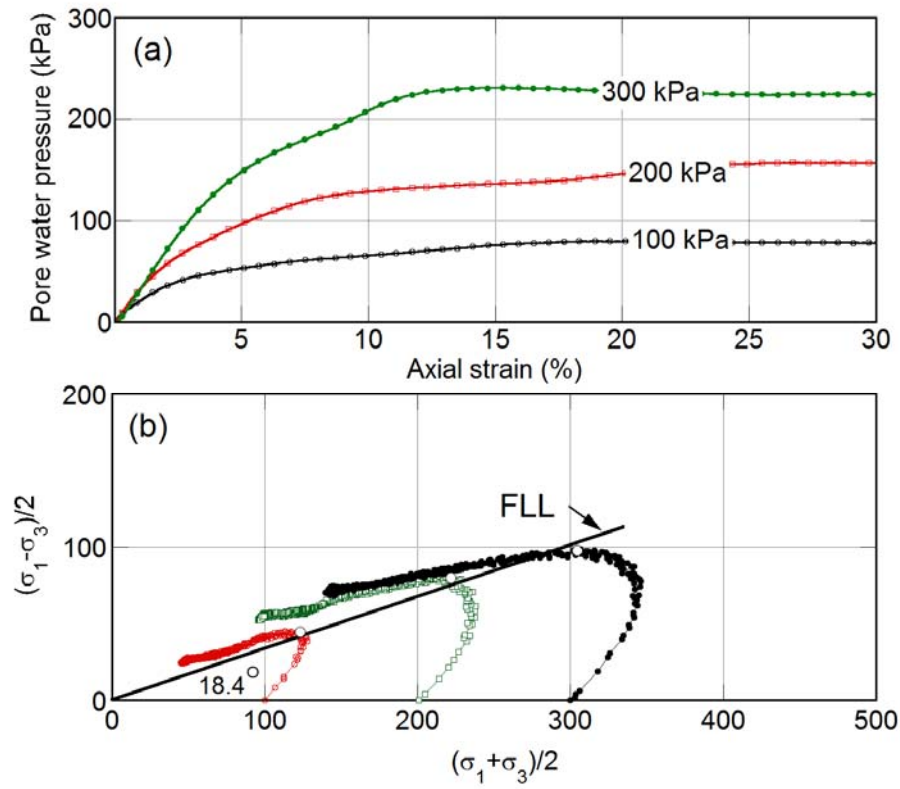
Fig. 14. Undrained triaxial compression tests on remolded sample ($e=0.79$). (a) Pore-water pressure against axial strain; (b) Effective stress path. FLL: Flow Liquefaction Line.

As reported by Yang (2002), the slope of the flow liquefaction line varies with both the materials and the soil state. Wen and Yan (2014) examined the influence of structure on shear characteristics of unsaturated loess and found that peak shear strength and strength parameters (cohesion and friction angle) of the loess were significantly reduced once its structure was destroyed. Considering that some loess in the lower part might have been disturbed before the earthquake by human activities, we performed three undrained triaxial compression tests on remolded loess samples to examine the possible variation of the flow liquefaction line with the soil state. The remolded samples in these tests were prepared at the same density as that of the undisturbed samples, and testing procedures were unchanged from those used during the undisturbed tests. Fig. 14 presents the test results. As can be seen, similar to results from tests on undisturbed samples, pore water pressure continuously increased with increasing axial strain, and all tests showed flow liquefaction behavior. However, the slope of the flow liquefaction line is approximately 18.4 degrees, gentler than that for the undisturbed samples shown in Fig. 11b. Therefore, we can conclude that the remolded loess is more prone to flow liquefaction than undisturbed loess

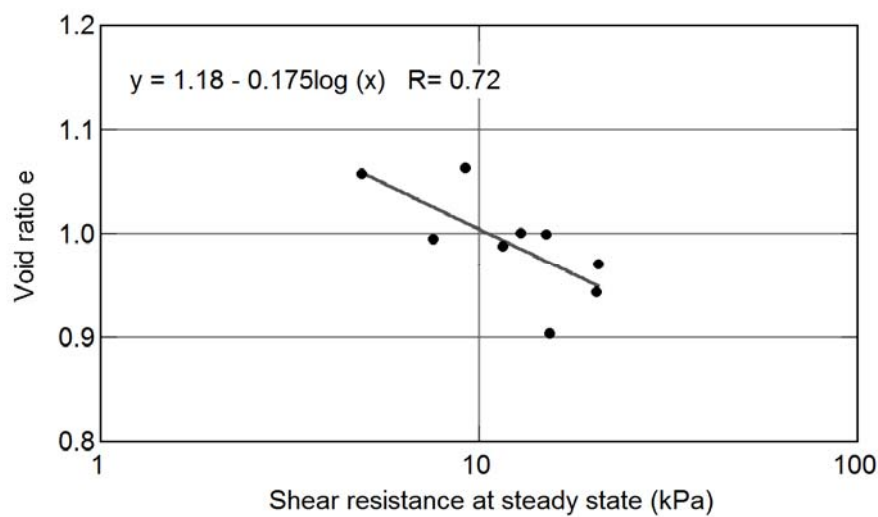
Fig. 15. Shear resistance at steady state versus void ratio for water-saturated loess samples

Based on the concept of critical void ratio defined by Casagrande (1936) and on the results obtained from undrained monotonic loading tests on saturated sand, Castro (1969, 1975) introduced the concept of the steady-state line. Thereafter, the steady state approach for the analysis of liquefaction susceptibility has been used in practice. The most important assumption in this analysis is that the sand has a unique steady-state line in void ratio-effective stress space; this line can be determined from the results of undrained tests on loose specimens of sand, and only those sands with their initial normal stress and void ratio located above the steady state line can experience liquefaction flow failure (Castro 1969; Castro & Poulos 1977; Poulos 1981; Kramer 1996; Yang 2002). We performed a series of monotonic shear tests on water-saturated loess specimens at different initial void ratios. Probably due to the small value of the applied initial normal stress (200 kPa) and the specimen preparation method, the void ratios of tested specimens ranged from 0.9 to 1.1, showing no significant difference. Each specimen was sheared to steady state. The steady-state points for all the tests are shown on the e versus $\log(\tau_s)$ plot (Fig. 15). Based on these data, a steady-state line was obtained by regression. Using the measured in-situ unit weight (γ_d) of 15.0 kN/m³ (the largest value, which corresponds to a void ratio of 0.79) for the loess layer in the source area, a possible maximum thickness (H) of about 50 m (from the cross section along I-I' shown in Fig. 4a), and the slope angle (θ) of 20 degrees, we estimate that the shear stress acting on the potential sliding surface ($\tau = H\gamma_d \sin\theta \cos\theta$) before the sliding was about 180 kPa. This initial shear stress and the in-situ void ratio will plot above the steady-state line shown on Fig. 15. Hence, once shear failure occurred during the earthquake, the shear resistance of the water saturated loess layer near the sliding surface would drop to a very small value due to liquefaction, and then the great difference between the driving shear stress and the lowered shear resistance would result in the accelerating movement of displaced landslide materials.

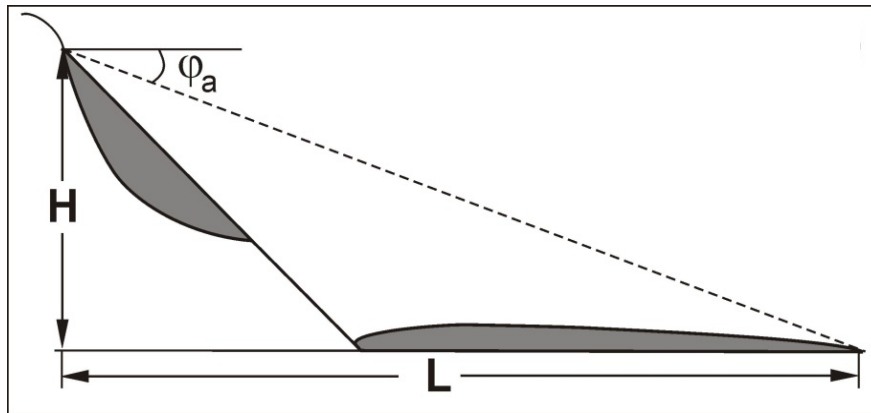
Fig. 16. Definition of the travel angle (ϕ_a) for a landslide

In the analysis of landslide mobility, the parameter of travel angle (ϕ_a) has been widely used (Scheidegger, 1973; Cruden and Varnes, 1996; Legros, 2002; Crosta, et al., 2005). ϕ_a is defined as $\tan\phi_a = H/L$, where H is the vertical landslide height of and L is the horizontal landslide length measured from the crest to the toe of the landslide (Fig. 16). This value of $\tan\phi_a$ is also called apparent friction, and ϕ_a apparent friction angle. Low apparent friction angles indicate high mobility. According to Sassa (1996), this apparent friction angle can also be obtained from undrained ring shear test results as the mobilized friction angle at steady state $\phi_m = \arctan(\tau_s/\sigma_i)$, where τ_s is shear strength at steady state and σ_i is initial consolidation normal stress.

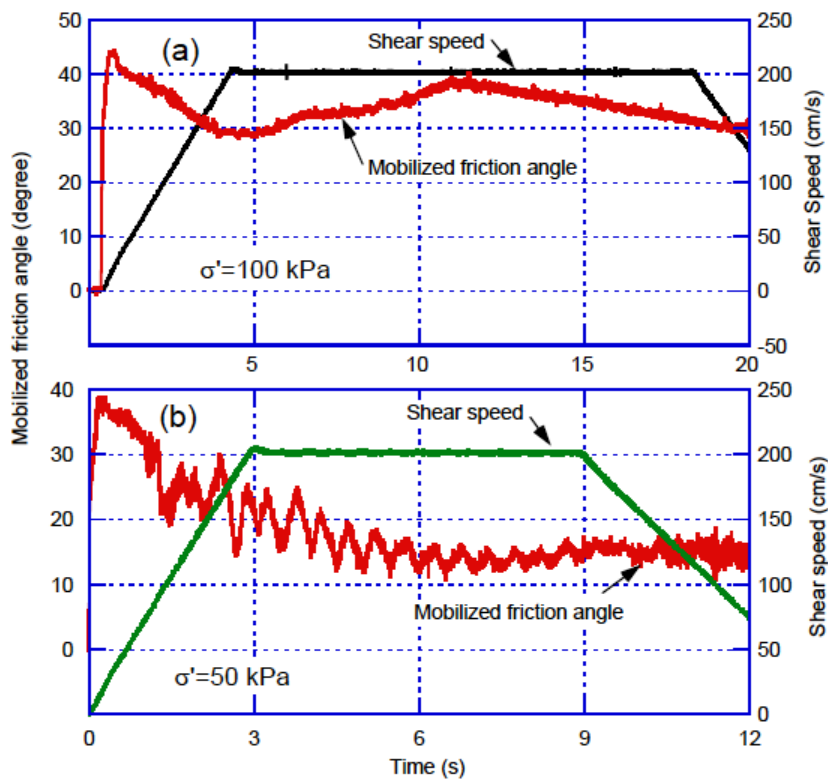
Fig. 17. Results of tests on air-dried loess samples that were consolidated under the initial stress of (a) 100

kPa ($e = 1.42$), and (b) 50 kPa ($e = 1.43$), respectively.

Based on the concept of the mobilized friction angle, the possible effect of entrained air on the landslide movement was examined by conducting a series of undrained fast shear tests on air-dried loess samples. The samples were normally consolidated under initial effective normal stresses (σ_i) of 50 and 100 kPa. In these tests, the observed pore-air pressures were within a narrow range (20-27 kPa), but the mobilized friction angles were different (Fig. 17). The test under $\sigma_i = 100$ kPa indicated a mobilized friction angle of 30 degrees during the shear process, whereas the test under $\sigma_i = 50$ kPa showed a significantly lower value of ϕ_m of about 13 degrees.

For flow liquefaction cases, it has been found that water-saturated specimens initially consolidated at the same void ratio but at different confining stresses display equivalent steady-state shear resistance (Sladen et al 1985; Ishihara 1993; Kramer 1996; Yang 2002; among others). Hence, the mobilized friction angle will decrease with increasing initial normal stress. However, the results shown in Fig. 17 indicate that, for the air-saturated specimens, the mobilized friction angle increased with increased initial normal stress. This may result from the following facts: (1) air is more compressible than water and, consequently, more compressible space is needed for air-saturated samples to ensure the generation of the same magnitude of pore pressure as for water-saturated samples; and (2) the limited compressible space does not allow the generation of higher pore-air pressure and consequent significant reduction in shear resistance.

From Fig. 17, we can conclude that increased pore-air pressure would have less effect on the mobility of deep-seated landslides because the reduction of effective normal stress from elevated pore-air pressure is negligible when the normal stress is large (i.e., the landslide thickness is great). Moreover, it is worth nothing that the test shown in Fig. 17b was performed under an idealized undrained condition. In the field condition, high permeability of soil with large pore spaces and abundant cracks may enable the quick dissipation of generated air pressure. Hence, any shear-induced generation of air pressure in the field would be smaller than in the laboratory to the extent that its contribution to the high mobility of shallow landslides may be ignored.
